**NBSIR 73-267**

# Report of Fire Tests on Flexible Connectors in HVAC Systems

Final Report

Prepared for American Iron & Steel Institute New York, New York 10017

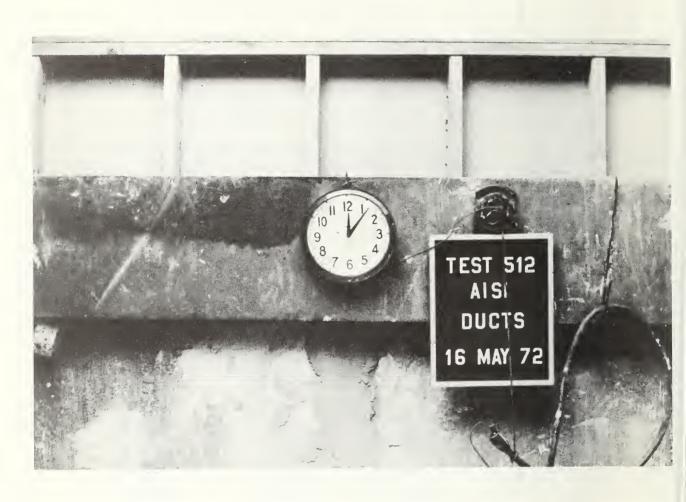
Figure 2 - Test 512- Side of Raised Furnace Closure

In the pilot test a 24 inch x 24 inch square duct 10 ft in length was hung from a ceiling closure constructed over the NBS floor furnace. In order to clear the duct over the furnace burners, it was necessary to build a hood-type closure which extended about 24 inches above the top of the furnace. See Figure 1 which shows the test layout and Figure 2 which shows a side view of the closure.

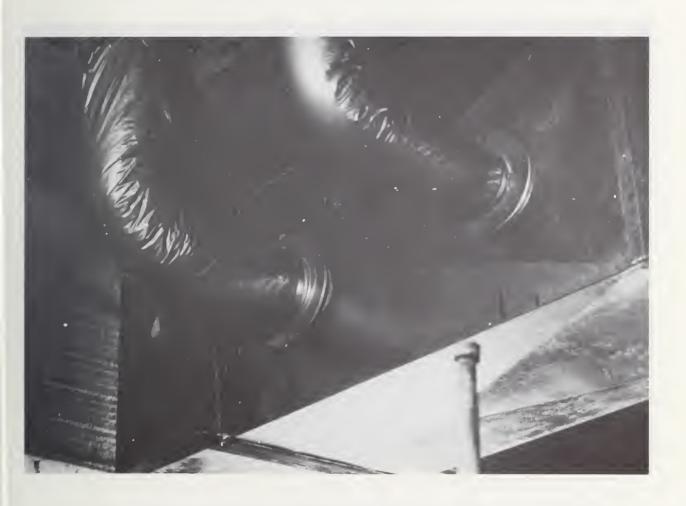
Figure 3 - View of Steel Connectors Showing the Vinyl Covering and the Method of Attaching to the Duct.

Within the furnace both the woven glass fiber connector, and the steel connector were wrapped with a l inch thick glass fiber and covered with a vinyl plastic cover, which was supplied by the manufacturer of the flexible connectors. As in the pilot test, the main ducts and the connectors were painted with a rated vapor barrier. See Figures 14A and 14B.

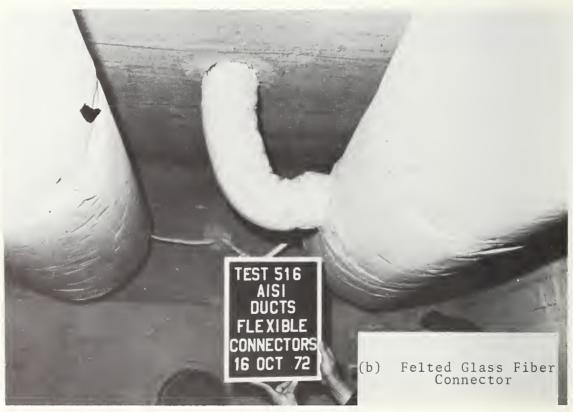
Figure 14 - Penetrations through Closure

The penetrations through the furnace closure were altered from that used in the pilot test. The hole through the closure was only slightly larger than the connector and because of this tight clearance no glass fiber was packed into the space around the connector. On the fire side, the hole was blocked with a steel flange plate. The plate for the 6 inch diameter steel connector, which was supplied by the manufacturer of the flexible connectors, was made of stamped 19 gauge steel. The plates for the 5 inch diameter connectors were fabricated at NBS of welded 16 ga. steel. For the glass fiber duct, a suitable flange plate was unavailable at the time of the test so the hole around the duct was packed with glass fiber and was protected with vermiculate plaster on the fireside. Figure 13A shows the welded flange plate and Figure 13B shows the pressed steel flange plate. Figure 14A and 14B show the penetrations through the furnace closure for the steel and felted glass fiber connectors, respectively.

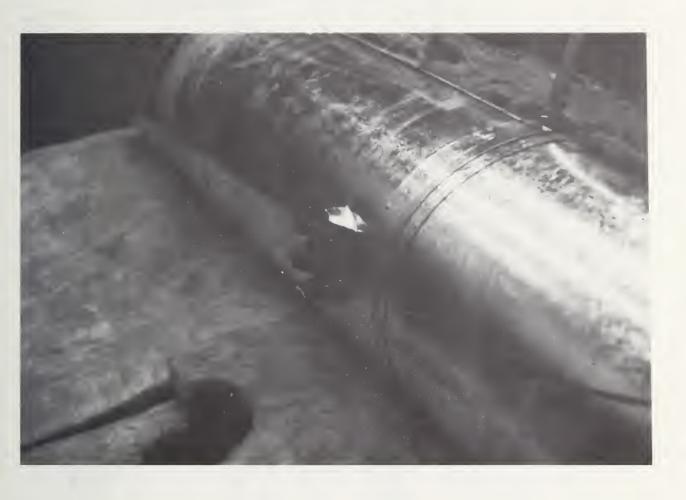
Figure 15 - Typical Duct Showing Glass Fiber Blanket and Connector Junction Point

For this test the attachment of the steel connectors to the main ducts was changed to represent a common field type, as shown in Figures 12 and 15. Instead of using a flanged plate on the duct a small hole was cut in the duct and radial cuts were made from the edge of the hole out to the radius of the connector and the resultant strips were bent out to form ears. The connector was attached to the ears with a steel friction band. In addition to the bands, four self threading sheet metal screws were used to attach the connector to the bent out ears.

As in the pilot test, the main ducts were covered with a rated two inch thick aluminum foil-backed glass fiber blanket. This was attached with a rated adhesive and rated tape, see Figure 15.

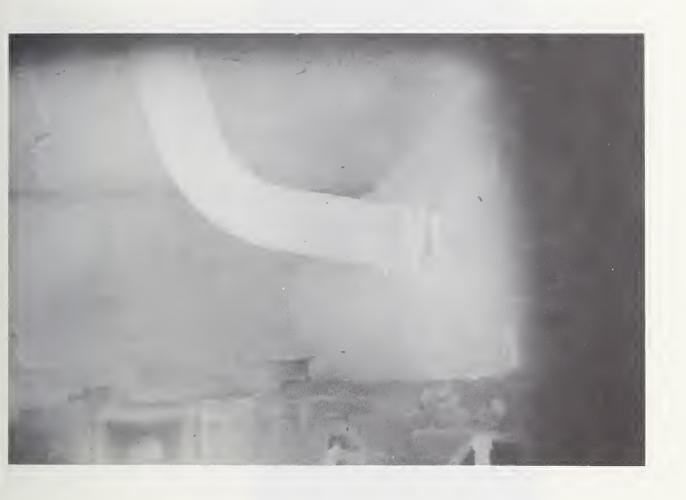
During the test it was observed at 32 minutes that the 5 inch connector was separating from its duct. However, the abrupt rise in temperature at the outlet of the architectural enclosure would indicate that the separation probably occurred at about 20 to 25 minutes. This separation which is shown in Figure 31 allowed hot furnace gases to enter this assembly and so produce the higher observed temperatures in the 5 inch connector assembly.

Figure 31 - Separation of 5 inch Steel Connector from Main Duct
